Manhole Inspection Summary

Manhole # S05II2021MH

Insp Date: **7/10/06 7:35 AM**

Location Address: **2511 GREENSPRING AVE**

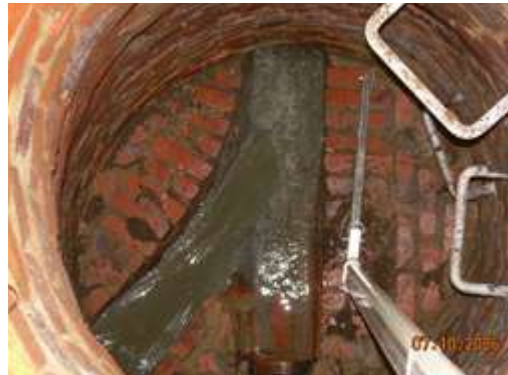
Top View

Adjustment and Barrel infiltration. Bench debris.

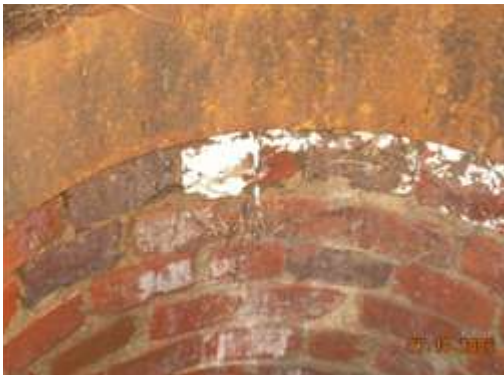
Defect

Adjustment root intrusion and infiltration.

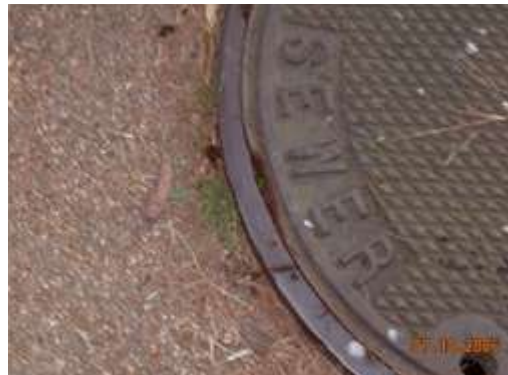
Defect

Chipped cover.

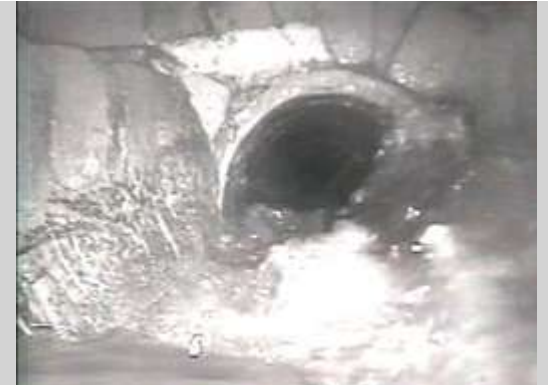
8 in. Circular Gravity Sewer Pipe Out @ 12 O'Clock

Comments **The O12 pipe picture shows Channel deterioration and root intrusion. The I6 pipe picture is not flush to the pipe.**

Deposits: ☐ None ☐ Mud ☐ Sludge ☒ **Debris** ☐ Grease

Silt Depth: **1** (in.) Deposits Extent: **Light**

Infiltration: **Evidence** Pipe Seal Cond: **Unknown**

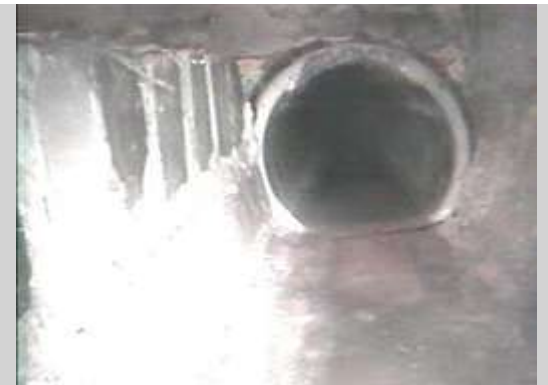
8 in. Circular Gravity Sewer Pipe In @ 6 O'Clock

Infiltration: **Evidence** Pipe Seal Cond: **Roots**

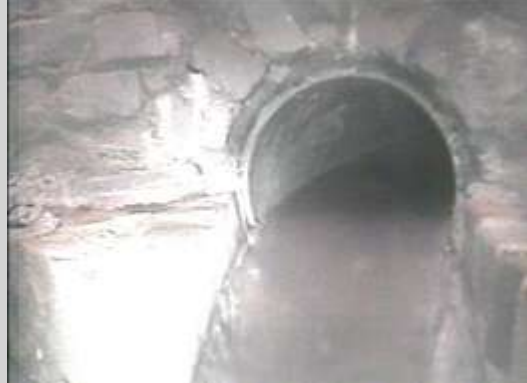
Pipe In @ 7 O'Clock

Infiltration: **Evidence** Pipe Seal Cond: **Unknown**
